Is gypsum external rendering possible? The use of gypsum mortar for rendering historic façades of Valencia's city centre

Camilla Mileto, Fernando Vegas and Vincenzina La Spina

Instituto de Restauración del Patrimonio, Universidad Politécnica de Valencia,
Camino de Vera s/n 46022 Valencia, Spain

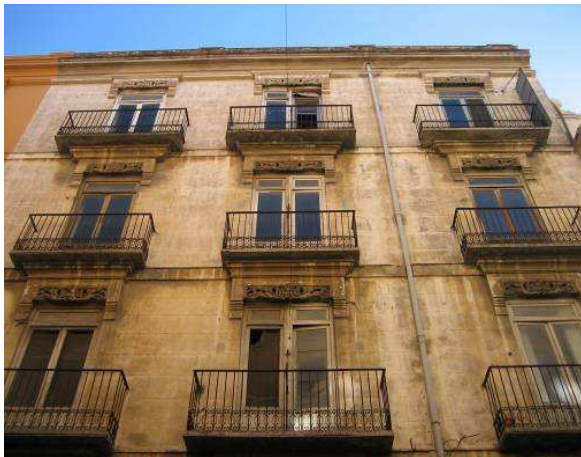
Fig. 1: Façade of a historic building in Valencia's city centre with historic external rendering. V. La Spina.

The city centre is characterized by five different neighbourhoods where buildings and, therefore, their façades have suffered many modifications and changes throughout time. However, most of the historic buildings are dating from the end of the 18th century and the beginning of the 19th century. Generally, they are residential buildings and 3-5 storey blocks of flats, made of supporting brick walls, brick columns and wooden beams. The use of external renderings in order to cover and protect brick masonry walls has a long tradition in residential buildings because it was cheaper than stone masonry. Stone masonry was used exclusively for public buildings and possibly for isolated lintels, jambs...in brick fabrics. In addition, the ornamental coat of external renderings has allowed the imitation of fashionable bonds in every history moment (Fig.1).

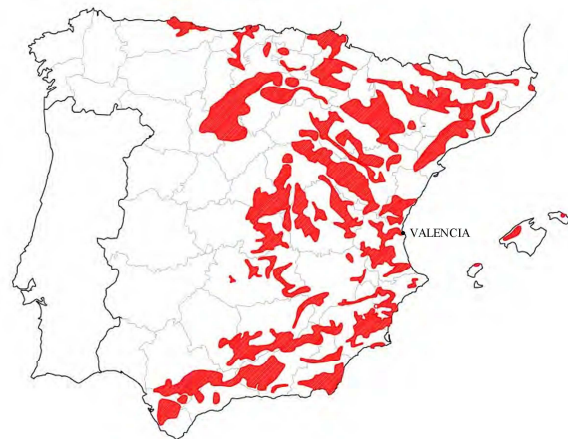
Fig. 2: Map of gypsum deposits in Spain, adapted by D. Sanz Arauz, from the original map of Riba and Macau (1962).

Specifically, in Spain most of gypsum mortars are found in constructions from the 18th, 19th and the first half of 20th century, in cities and towns in the East of Spain such as Cuenca, Albarracín or Ademuz [4]. This has been possible thanks the existence of large gypsum deposits in this area of Spain (approximately 35.000 km² of surface) (Fig. 2). Moreover, there are traditional constructions in this area where gypsum is used both to render exterior façades and to build up walls, floors or pillars. In the area of Valencia there were also gypsum deposits at an only 20 km distance and a gypsum manufacturing industry already existed in the 16th century. Therefore, gypsum was abundantly used in external renderings in Valencia.

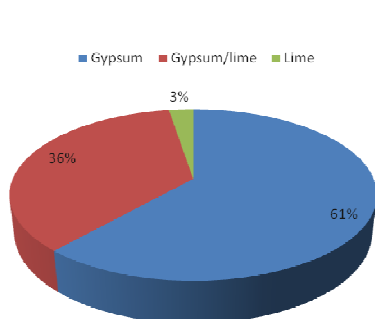
Fig.3: Percentage of raw materials in historic mortars of Valencia's coatings.

The analytical data shows that the historic mortars of Valencia's historic centre have a great percentage of gypsum, over 90%. However, only 60 % of the samples are exclusively made of gypsum, as some of them have simultaneously gypsum and lime (Fig. 3). According to the estimated dosages, it is possible to state whether the mortar was a gypsum-based one mixed with some lime or if the gypsum was used as an additive to accelerate the hardening of a lime-based mortar. And, other traditional additives have been detected in the composition of some mortars such as hair, vegetal fibres or other impurities that improve their performance and qualities.

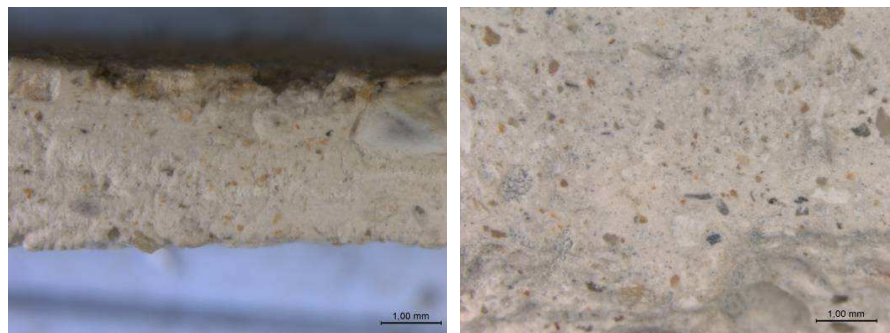
Fig. 4: Microphotographies (x8) of a gypsum external rendering. Left: 3mm thick finish coat containing 83% of gypsum. Right: 91% gypsum basecoat and with bigger size of sand.

It is also necessary to highlight that the composition of the mortar is different in every layer of the external rendering. In some cases it is only a different quantity of each material (Fig. 4). Nevertheless, in other cases, the kind of mortar is different in every applied layer, and for example the finish coat is a gypsum-lime mortar while the basecoat is a gypsum mortar. Likewise, there are areas in the façade, such as the lintels and the jambs of windows and doors, where it has been possible to observe a better quality of mortar, and specifically in the case of gypsum mortars, a scarce use of sand in order to increase hardness and resistance for the external rendering.
